## USERS' EXPERIENCES WITH QUALISTAR+

In this Case Study, we present the experiences of user-customers in various contexts. The **Qualistar+** three-phase network and power analyser is a measuring instrument for diagnosing anomalies and performing preventive or corrective maintenance. It can be

## CASE No. 1 - Untimely shutdown of PLCs

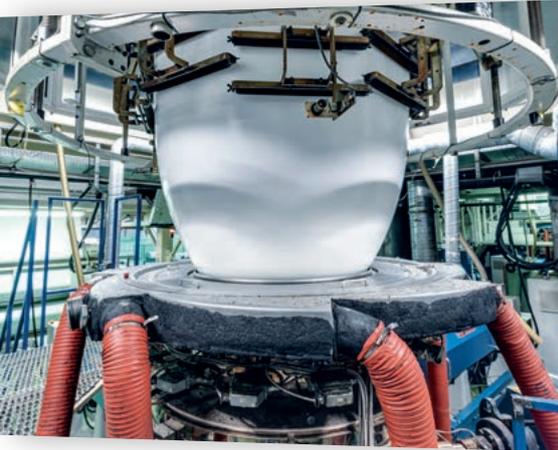
In a plastics factory, the PLCs controlling the production lines register an error. It turns out that the unit for injecting plastic into the moulds has broken down. The same problem had already occurred a few weeks earlier. The electronic board in the injection unit was replaced under the terms of the warranty. This time, the board is sent for repair but is no longer covered by the warranty. Inspection of the board shows that it was damaged by a voltage surge. Convinced that the product is unreliable, the supervisor of the plastics workshop decides to perform the measurements himself and therefore borrows the Qualistar+ electrical network monitoring equipment.

1 The instantaneous no-load voltages are OK. The Qualistar+ is then set up to record over several days. Analysis of the recording shows that voltage surges are occurring. These surges happen regularly on all three phases. This quickly calls into question the electricity supply, so monitoring is immediately resumed just downstream of the meter.

2 The new recording shows the presence of inrush currents and, above all, voltage spikes: each transient corresponds to a peak in the current. Only an old bending press is used in this workshop to manufacture the metal frames for boats. Suggested initially by the workshop technicians present, this line of enquiry was abandoned prematurely because the interruptions were not systematic when the bending press was in operation.

**Solution** : set up a corrective system on the electrical feeder of the bending press.

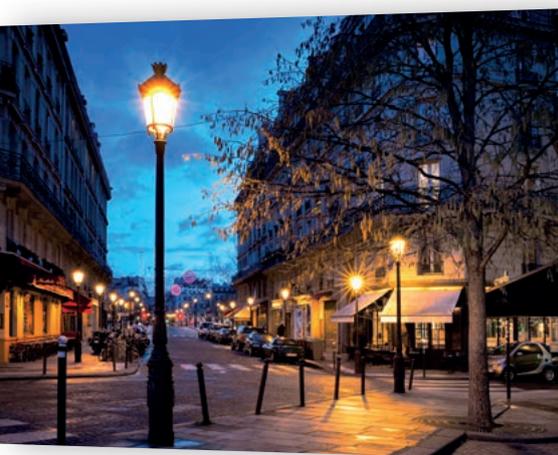
## CASE No. 2 - Abnormal startup of a UPS

An all-night pharmacy open 24/7 is equipped with an uninterruptible power supply with a battery. The UPS starts up on its own, even though the operation of the equipment connected has not changed and no loads have been added on the network. A technician from the inspection organization responsible for the site comes to take the measurements.

The first series of measurements 1, a trend recording, is performed on the output from the UPS. All the characteristics of the energy supplied are recorded and no anomalies are detected. The same characteristics are then measured upstream of the UPS 2. This time, the recording clearly shows a significant rise (several tens of Volts) in the Neutral/Earth voltage. The technician has noticed that these peak values occur when the street light comes on! In winter, the lights come on earlier!

After the installation of new lights in the street, the 2 earth connections (lamp post and building) are very close to one another, leading to interference.

**Solution** : move the earth connection of the building

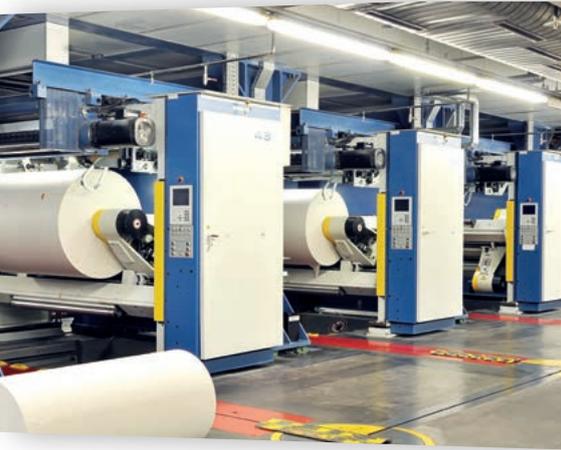
## CASE No. 3 - Lighting problems

A printing company with 4 workshops working shifts round the clock, as well as administrative offices, has encountered difficulties with its lighting. The RCDs protecting the electrical feeders for the lighting keep tripping and bulbs burn out at random. This problem only occurs in winter, but not in summer.

First, the technician takes measurements on the power supply for the lighting. He measures the harmonics on the voltage and current, as well as the transients. The results show that there are no transients and that the level of harmonics present is satisfactory.

When workshops 2 and 4 are powered, 7th order harmonics appear. This increase in the level of the harmonics is considerable. The technician then suspects resonance with the capacitor banks for power factor correction positioned upstream of the electrical feeders for the motors.

**Solution** : set up an anti-harmonic filter sized for the distorting current causing the fault.

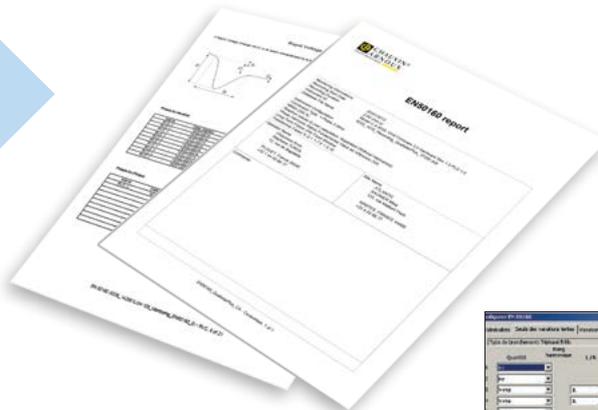
In a hospital, they have just made a major investment, buying a PET SCAN. The manufacturer of the equipment imposes certain characteristics in terms of the electricity supply to ensure that the equipment can operate correctly, without damage.

This concerns the following characteristics:

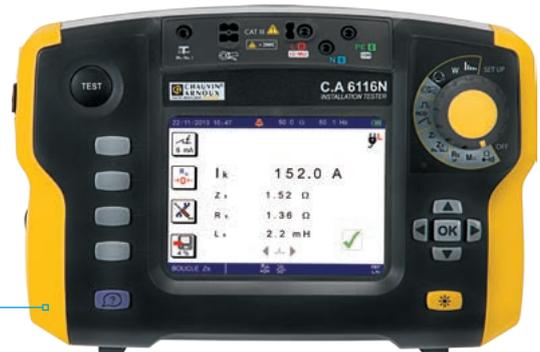
### C.A 6116N

- ▶ Multi-function inspection of electrical of electrical installations with storage of the results
- ▶ Earth, insulation, continuity
- ▶ Suitable for all neutral systems (TT, TN, IT)
- ▶ Measurement of the voltage drop for correct sizing of the conductor diameters
